Manhole Inspection Summary

Manhole # S31GG_042MH

Insp Date: 1/19/07 11:04 AM

Location Address: **1203 JOHN ST**

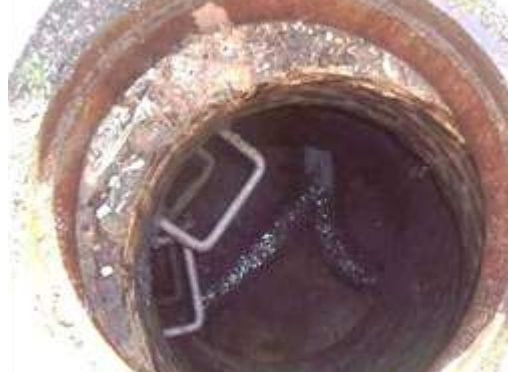
Top View

Corroded steps. Bench debris.

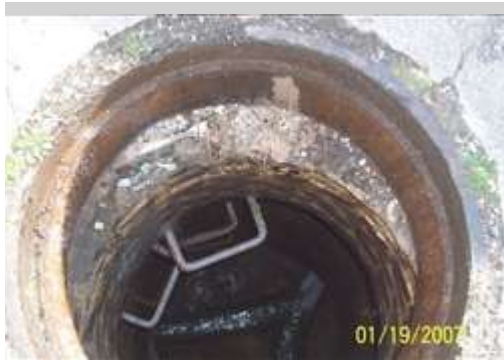
Defect

Frame leaks. Frame offset. Adjustment deterioration and infiltration.

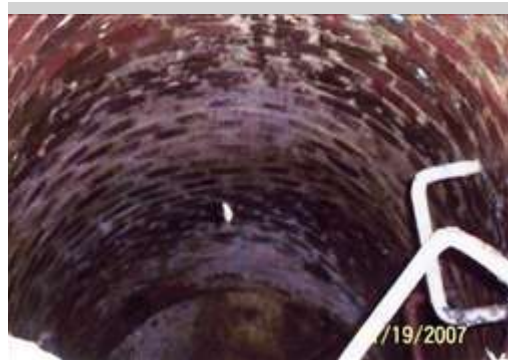
Defect

Corbel and Barrel infiltration.

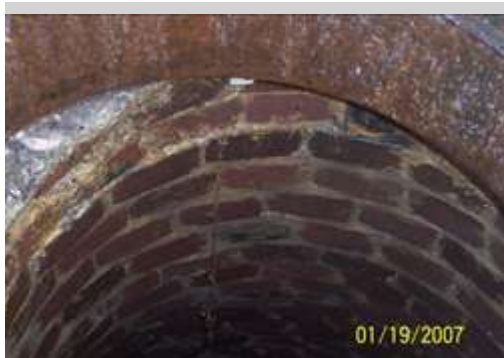
Defect

Adjustment deterioration, root intrusion and infiltration.

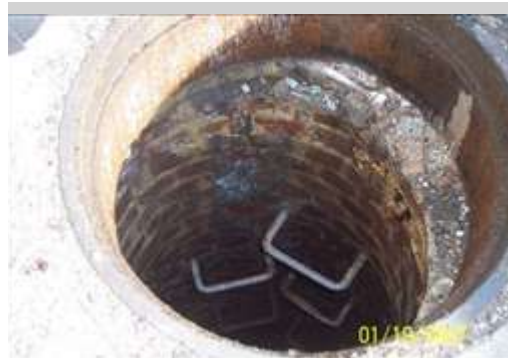
Defect

Frame leaks. Frame offset. Adjustment deterioration and infiltration.

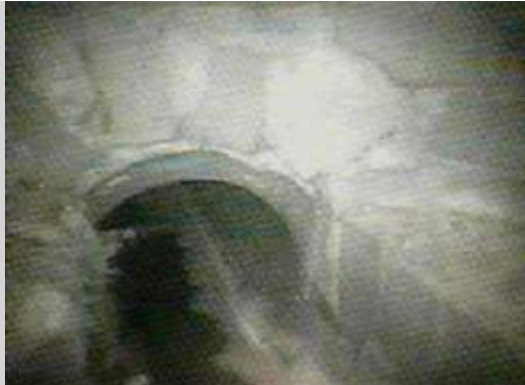
8 in. Circular Gravity Sewer Pipe Out @ 12 O'Clock

Infiltration: **Evidence** Pipe Seal Cond: **Roots**

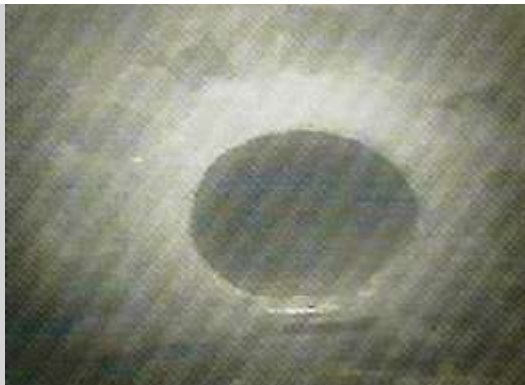
8 in. Circular Gravity Sewer Pipe In @ 4 O'Clock

Infiltration: **Evidence** Pipe Seal Cond: **Unknown**

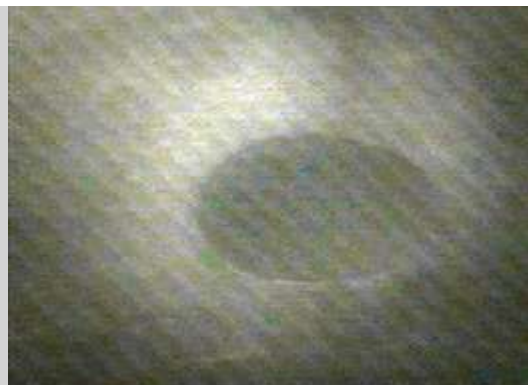
Pipe In @ 8 O'Clock

Infiltration: **Evidence**
